SOHO's Recovery – An Unprecedented Success Story

F.C. Vandenbussche

Scientific Projects Department, ESA Directorate for Scientific Programmes,
ESTEC, Noordwijk, The Netherlands

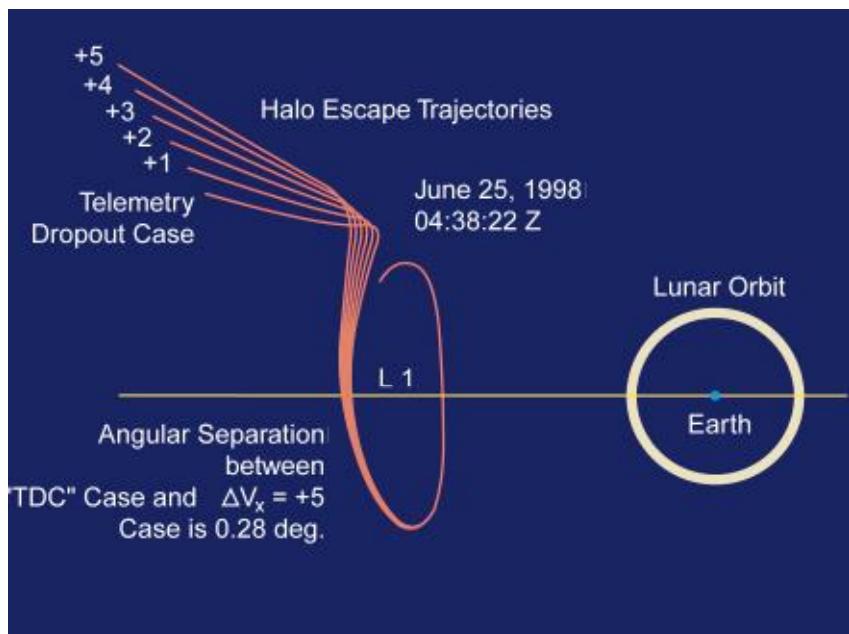
Figure 2. SOHO transfer trajectory and L1 halo orbit

SOHO's nominal trajectory is a halo orbit around the L1 Lagrangian point (Fig. 2), approximately 1.5 million kilometres from Earth. Halo orbits around L1 are inherently unstable and station-keeping (propulsive) manoeuvres must occasionally be used to stabilise them. If this reference trajectory is propagated from the point where SOHO's telemetry was lost and no additional delta-V is applied, it diverges only very slowly, retaining orbital halo characteristics up to mid-November 1998. Thereafter, the divergence would accelerate and eventually result in the spacecraft's escape into a solar orbit.
