SOHO's Recovery – An Unprecedented Success Story

F.C. Vandenbussche

Scientific Projects Department, ESA Directorate for Scientific Programmes,
ESTEC, Noordwijk, The Netherlands

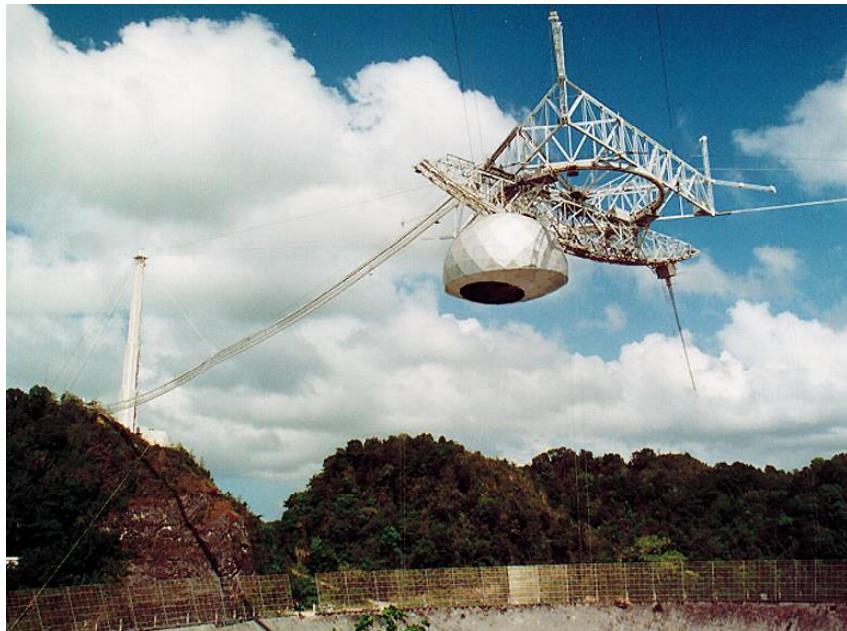
Figure 5. The Arecibo radio telescope in Puerto Rico

On 2 July, based on a proposition from researchers at the US National Astronomy and Ionosphere Center (NAIC), the 5-m diameter dish of the Arecibo radio telescope in Puerto Rico (Fig. 5) was used to transmit an S-band signal (at 2. 8 GHz and with a power of about 58 kW) towards SOHO whilst using the 34-m dish of NASA's Deep Space Network in Goldstone (USA) as a receiver, thereby locating the spacecraft's echo and tracking it for more than one hour. The radar echoes from SOHO confirmed its predicted location, and a spin rate of 1 rpm.
